Penarth No.7 (Footpath)

03 November 2016

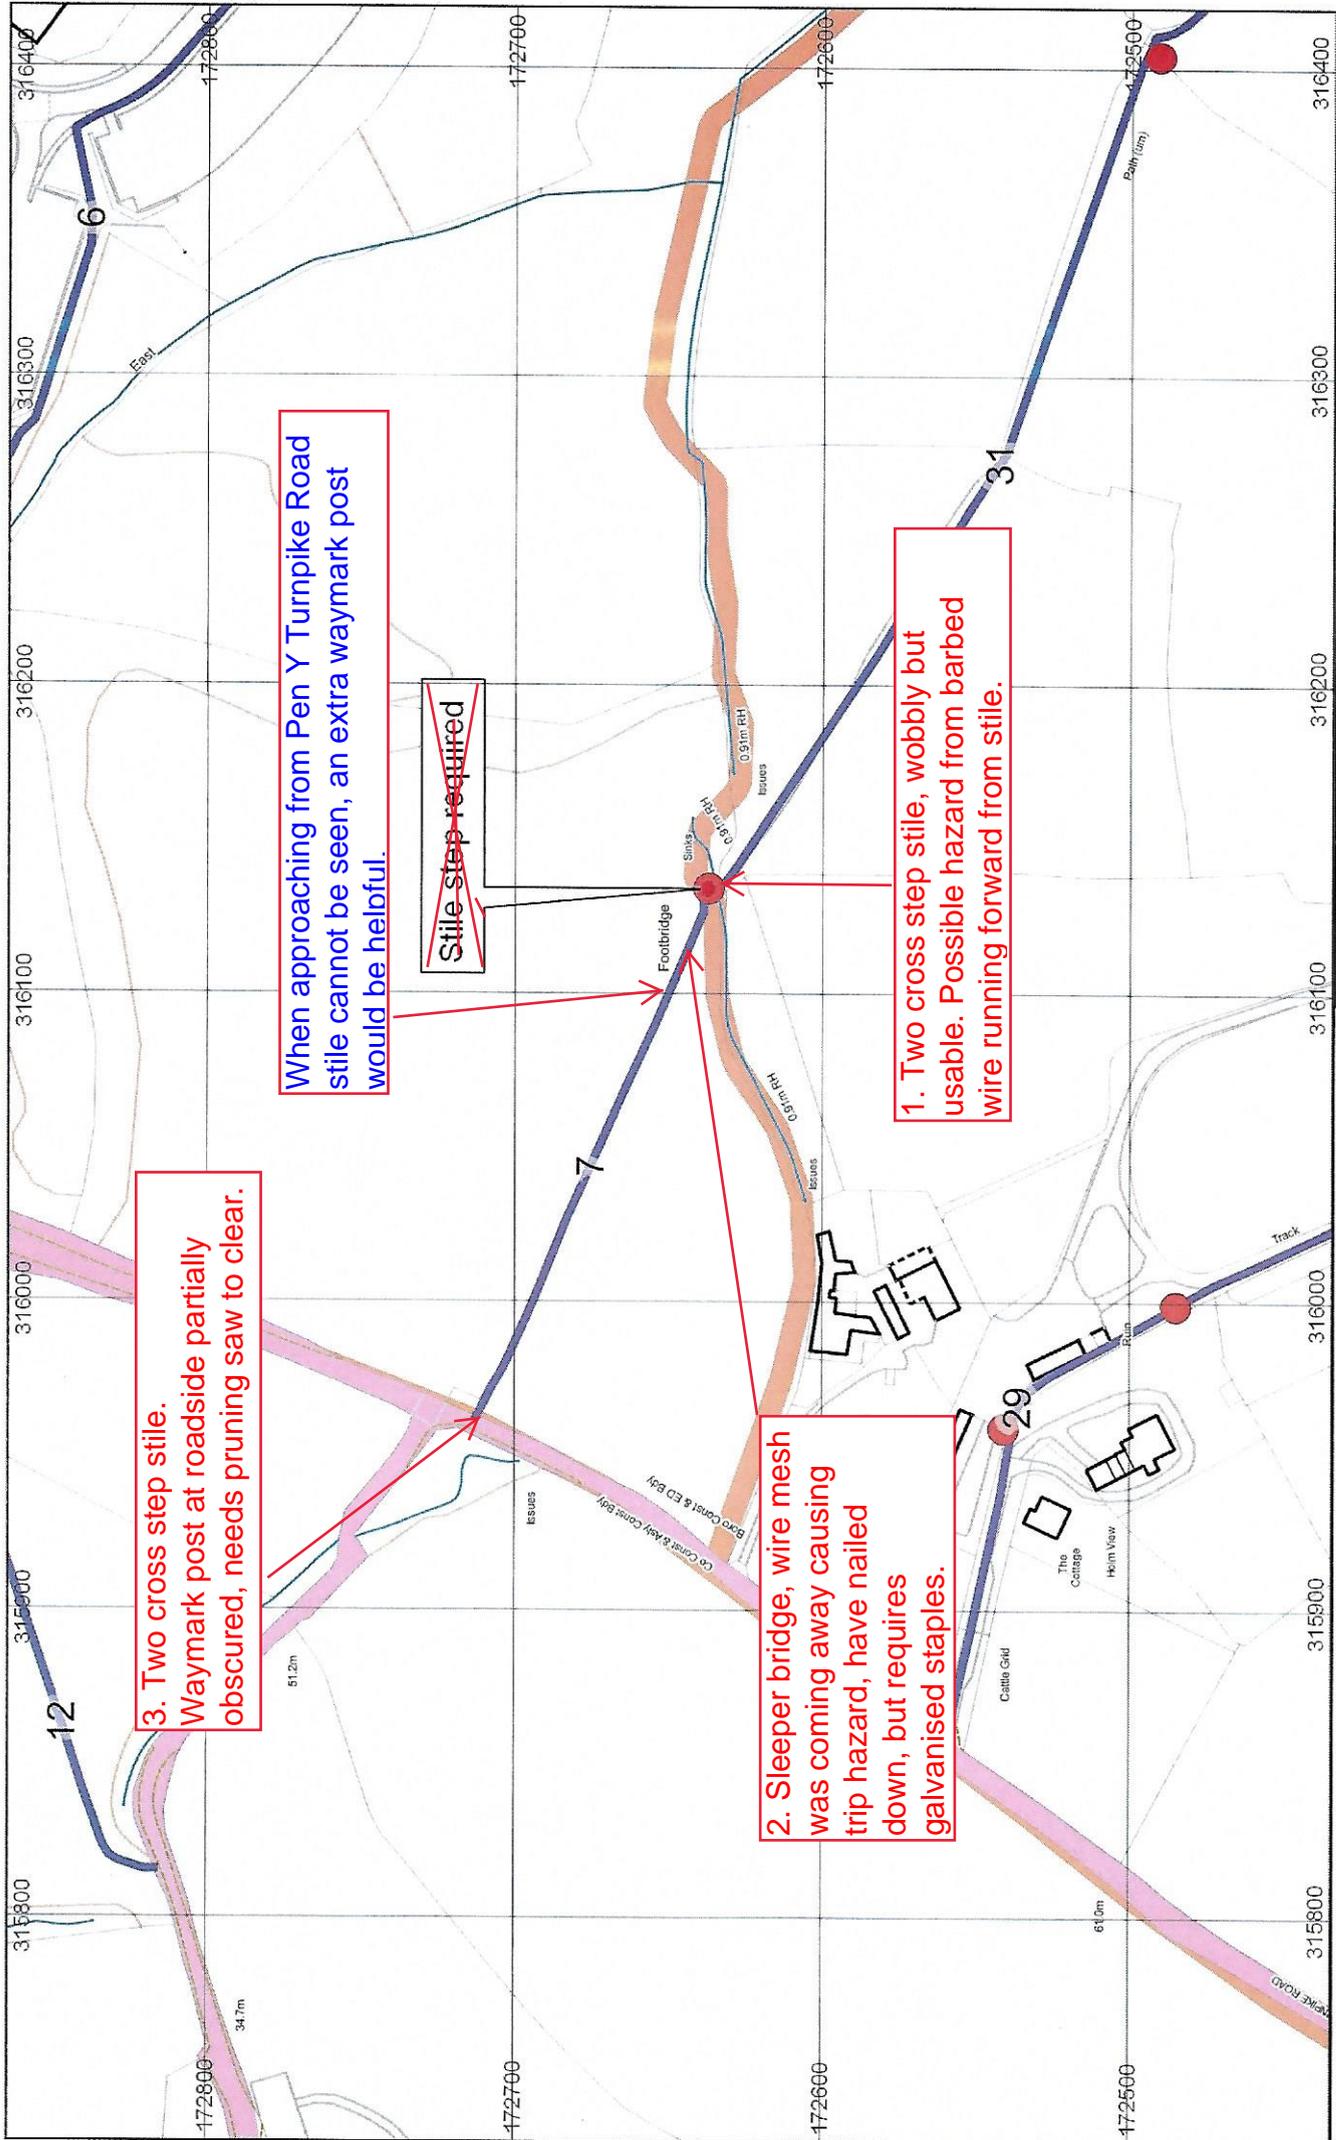
3. Two cross step stile.  
Waymark post at roadside partially obscured, needs pruning saw to clear.

When approaching from Pen Y Turnpike Road stile cannot be seen, an extra waymark post would be helpful.

2. Sleeper bridge, wire mesh was coming away causing trip hazard, have nailed down, but requires galvanised staples.

1. Two cross step stile, wobbly but usable. Possible hazard from barbed wire running forward from stile.

~~Stile step~~ required
